Laboratory study of driving rain resistance of four façade systems with window fittings - Experimental results of leakage flows

LABORATORY STUDY OF DRIVING RAIN RESISTANCE OF FOUR FAÇADE SYSTEMS WITH WINDOW FITTINGS – EXPERIMENTAL RESULTS OF LEAKAGE FLOWS

Lars OLSSON^{a,b}

^a Chalmers University of Technology, Civil and Environmental Engineering, Gothenburg, Sweden

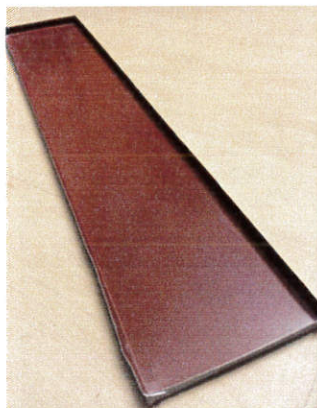
Moreover, collection trays with the dimensions 620 x 120 x 15 mm were positioned under each window frame (**Fig. 6**), except in the wall 2 with only two windows. Wall 2 was delivered in four smaller prefabricated elements and was assembled by the supplier in the steel test frame. Under each window and joint, laboratory staff installed collecting funnels made of plastic sheeting that were taped and sealed to the rear façade. Each funnel opened into a glass basin for collecting water. Additionally, two catchment chutes were fitted to vertical joints at the rear façade and moisture indicators at the bottom of the exterior of the wall frame.

Fig. 6 Photo of collection trays that were placed in the driving gap under the window frame
